Utah Regulatory Program Evaluation Evaluation Year 2002

Electric Powerlines: Design and Construction to Minimize Hazards to Raptors

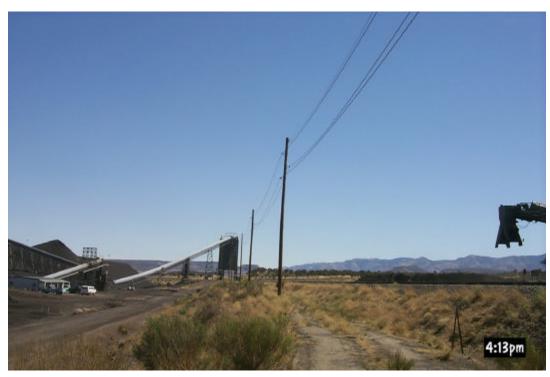
Photo 1. Wildcat Loadout. The three phase pole-mounted insulators were considered safe design when constructed in the early 1980's. Current designs allow greater distance between insulators and poles.

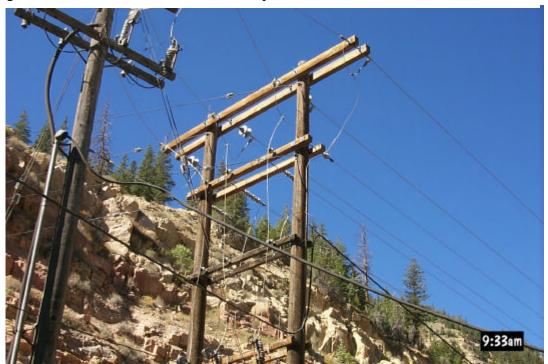
Photo 2. Deer Creek Mine. The complicated power pole and line configurations direct power to several locations. These complicated arrangements place numer-

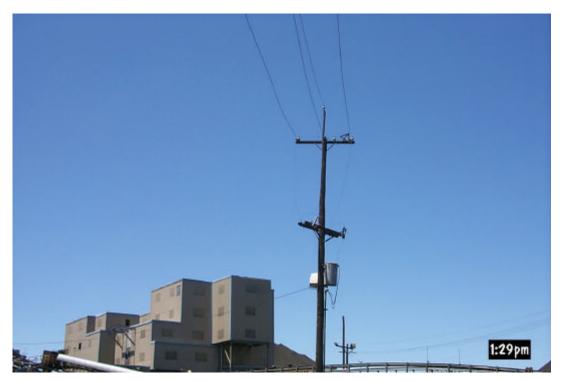
At Savage Loadout, eight structures were evaluated for raptor safety. The types of structures identified were three-phase, with several of the poles supporting transformers. Two structures were retrofitted with perch guards, however, these guards were not suitable for the structure and did not eliminate the electrocution hazard.

Photo 3. Savage Loadout. Energized lines less than 60 inches apart were retrofitted with inappropriate perch guards.

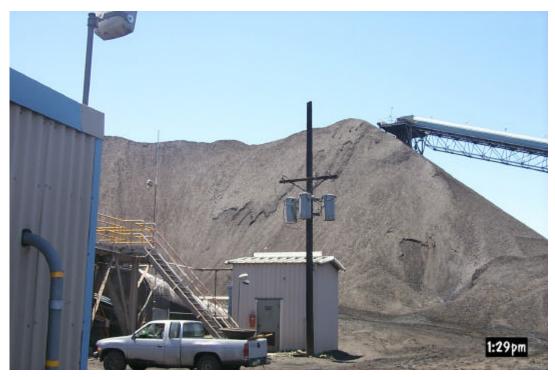
Photo 4. Savage Loadout. Transformers convert voltage to a specific usable level. Exposed wires and bushings pose electrocution risks.
